Title: Community Soak Pit (Vertical Filter) -Rejuvenating Local ecology by replenishing Ground Water

District : Erode; Block : Anthiyur

Erode District - Anthiyur Block - Brammadesam panchayat
MGNREGS 2018 -19
Community Soak Pit - Vertical Estimate Amount - 1.16Lakhs

District/ Block/ Gram Panchayat	Erode District/ Anthiyur Block/ Brammadesam Panchayat
Cost of the Project & FY	Rs 1.16 Lakhs/ FY 2018-19

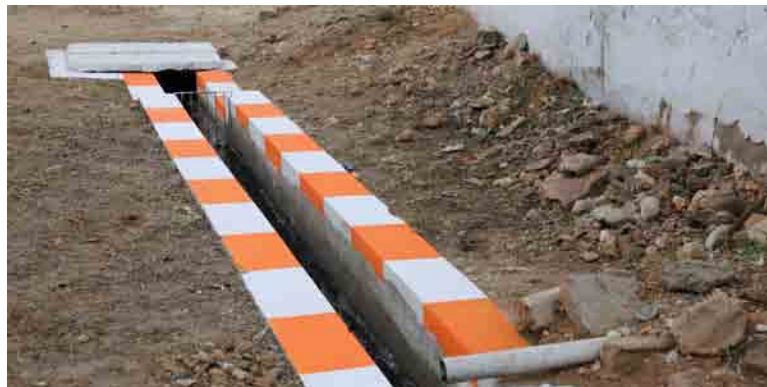
In Erode District, Anthiyur Block, Brammadesam Panchayat, The liquid waste water collected from the 75 households around the 4 streets namely West street, Bajani temple street,

Perumal temple street & Jallykulli street is stagnated at the low lying area which is located at the west end of the hamlet.
